Aviation Safety

Maintainer

Issue 1/2001

Backwards Trim Hookup

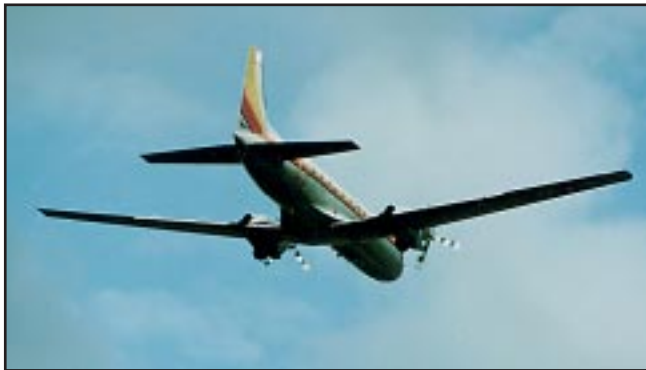
The pilots of the Convair 580 cargo flight were confronted with a severe nose-up pitch tendency immediately after takeoff. The aircraft had been loaded, and documentation, including the weight and balance sheet, maintenance records, and flight plan, was checked by the flight crew prior to boarding the aircraft. It was noted by the flight crew that considerable maintenance work had been done to the aircraft and that some of the work had involved the elevator and elevator trim. Despite this information and the fact that the aircraft was nearing an uncontrolled condition, the flight crew diagnosed the problem as a weight shift. The pressure of hands and feet on the control column by both pilots was barely enough to get the nose down for a safe landing—an extremely hazardous situation.

Back on the ground it was determined that the centre of gravity was within limits and not related to the actual problem. It was also discovered that the elevator trim tab was in the full nose-up position and moved in the opposite direction to the trim control wheel and to the trim indicator in the cockpit. A number of years ago, the Canadian Forces had several incidents resulting from

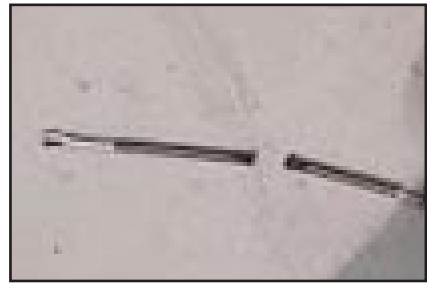
What failed: In this case, the failure of the system to extend the nose gear was caused by physical failure (bend) of part number 0842120-1 (tube assembly). This is a push-pull tube and is part of the mechanical linkage. It is the first tube in the series and is connected directly to the gearbox/transmission assembly mentioned above. The next push-pull tube forward in the system was also found to have a slight bend in it. There was no visible damage to either rod end. The tube had bent approximately 30° before breaking into two pieces approximately 13.5 in. from the aft end. The break appeared to be fresh with no visual sign of any previous cracking or breaking. The failed part, and the other tube that was found bent, is very difficult to inspect while still installed in the aircraft. The Continuing Airworthiness Program (CAP) for

Torque tube as removed from the Cessna 310 nose gear.

apply to this aircraft because of its serial number. There is a small access hole in the floorboards that allows inspection of the forward end of the push-pull tube where it attaches to the idler bell crank, and there is another small access hole in the aircraft's belly. However, neither of these would allow an inspector to fully inspect the tube to determine if there were any bends in it. It is possible that this tube may have had a small bend that was continuously developing to the point of failure.

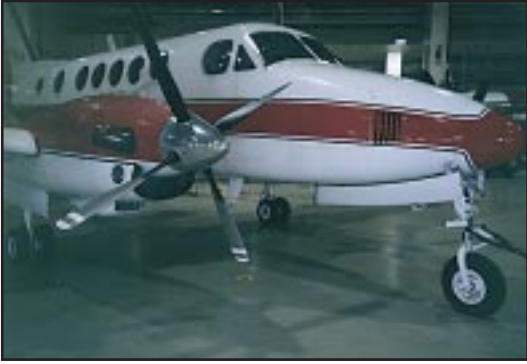
The crew of a Beech King Air 100 was unable to lower the gear properly using either normal or emergency extension procedures and landed with an unsafe indication. Although a fly-by confirmed that the gear appeared OK, it subsequently collapsed on landing with considerable damage to the aircraft.

The landing gear did not extend when selected down because the circuit breaker (CB) for the electric motor that operated the hydraulic pump had tripped. A major contributor to the problem may have been a leaking nitrogen system; this depleted the supply bottle because of a defective hydraulic accumulator that would not maintain the nitrogen charge. This would result in more frequent cycling of the hydraulic pump motor to maintain hydraulic pressure until the repeated recycling caused an overheated circuit, which popped the circuit breaker. The emergency landing gear extension failed to lock the right main gear for undetermined reasons.

1. Beech King Air 100 standard operating procedures (SOP) were amended to allow a single, in-flight reset of the electric hydraulic pump motor 60-amp CB.
2. The 60-amp CB in the accident aircraft has been relocated to the cockpit, similar to other King Airs in fleet that have Aviadesign STC hydraulic landing gear installed.
3. A mirror has been installed on the inboard side of the engine cowlings to allow observation of the nose gear from the cockpit for landing.
4. The company flight operations manual was amended to read “where practicable it is recommended that the pilot contact the applicable ASD operations centre, and state the nature of the problem, the assistance required, and the time remaining before a landing is necessary.”

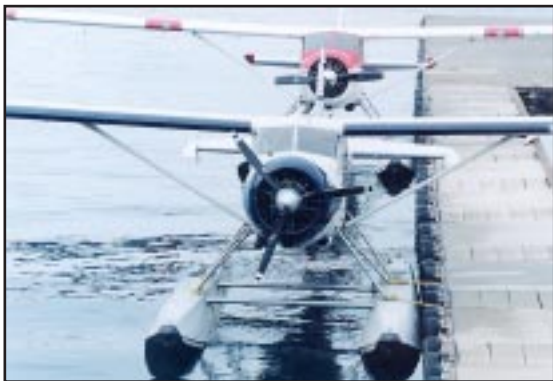
The aircraft crashed because of an engine failure about 45 min after departure from Mary's Harbour, Newfoundland, seriously injuring the pilot and front-seat occupant. The accident was apparently the result of water contamination in the fuel.

During recovery of the fuselage, the salvage team drained the centre tank. Maintenance observed a considerable amount of water present. Further inspection revealed varying quantities of water in other areas of the fuel system, including the carburetor fuel strainer, float bowl, and wobble pump fuel lines. What can be learned from this accident? Since water in fuel is always a hazard, probably the best lesson would be for all operators using remote fuel systems, such as barrels, to include the refuelling procedures and checks in the operations manual. Operators should ensure that crews follow the instructions, particularly checks for water and precautions against static electricity, during every such refuelling operation.
